August 1945 as  
Advance Restricted Report E5G06

PISTON-RING VIBRATION AND BREAKAGE

By J. C. Nettles and André J. Meyer, Jr.

Aircraft Engine Research Laboratory  
Cleveland, Ohio

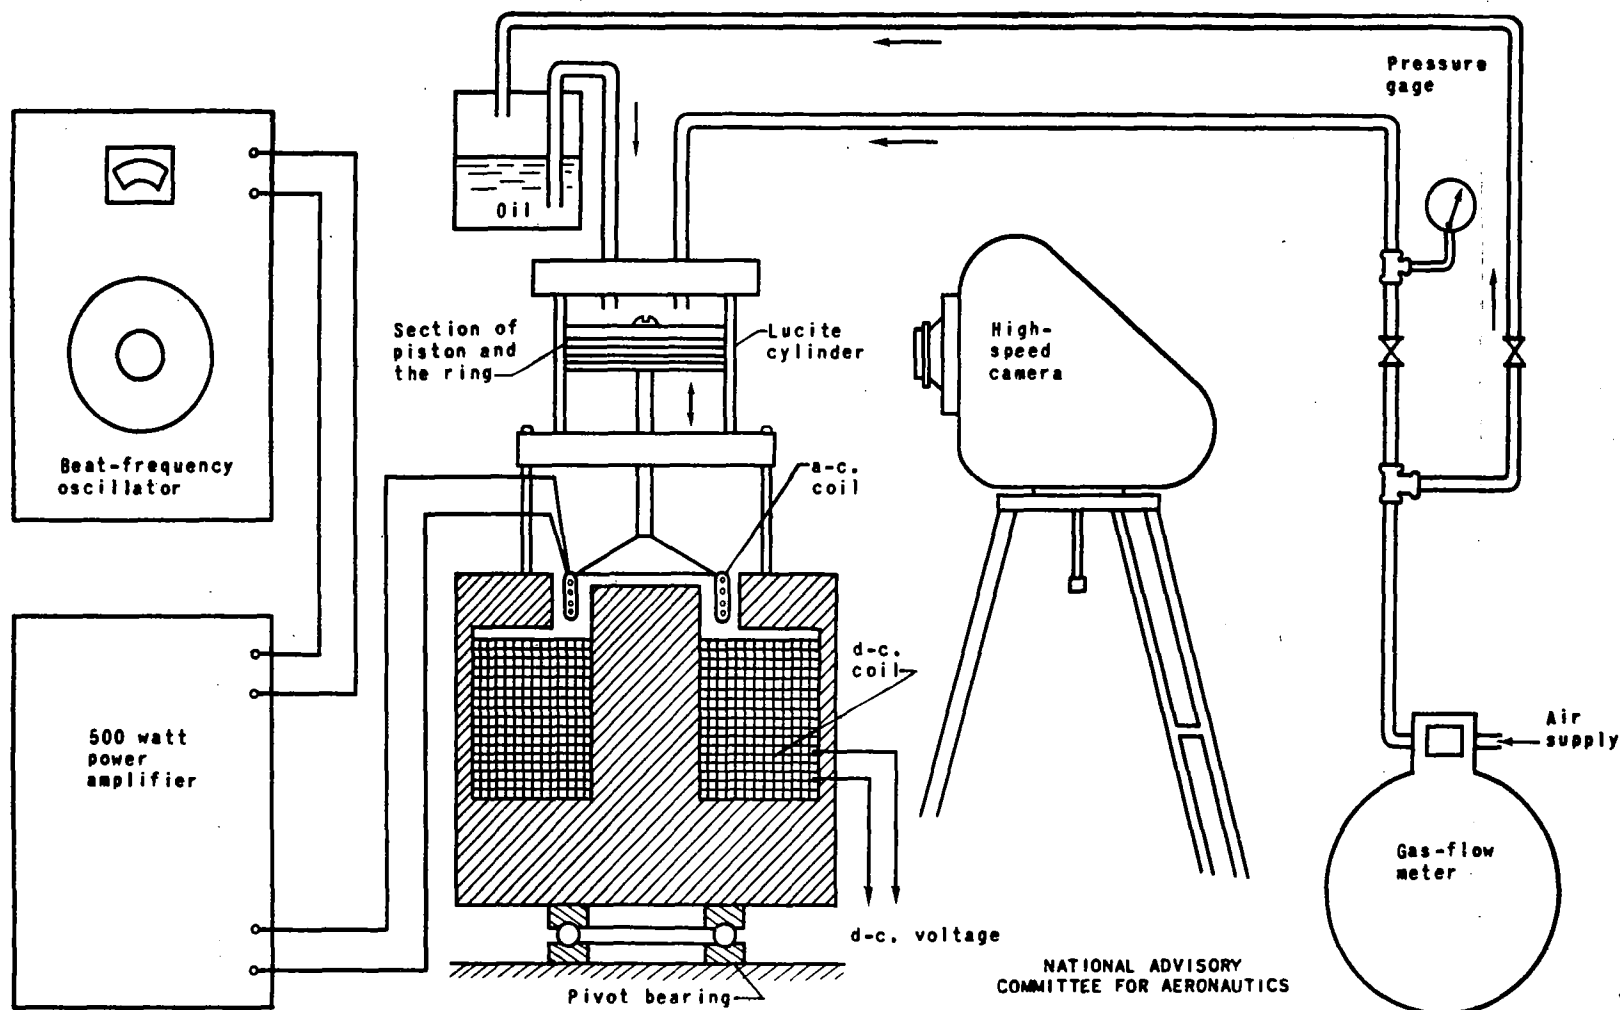
Figure 1. - Arrangement of test equipment used to oscillate and photograph a piston ring in a Lucite cylinder.

An electronic exciter was used to vibrate a keystone-type compression piston ring in the free state and when it was assembled on a section of a standard piston. The exciting apparatus consisted of a beat-frequency oscillator, a 500-watt amplifier, and an electric coil suspended in a steady magnetic field. A diagrammatic sketch of the test setup is shown in figure 1. The amplified output from the oscillator was passed through the coil. Because of its continually changing polarity, the coil was attracted and repelled; thus a means was provided for reciprocating the piston with ring in place at any frequency up to 1000 cycles per second. For frequencies below 100 cycles per second, the stroke was limited to 0.2 inch. For frequencies above 100 cycles per second, the stroke was limited to an amount corresponding to an acceleration of 250 times the acceleration of gravity. A polished Lucite cylinder was attached to the stationary part of the exciter to simulate the constrained conditions of a ring in an engine.

Ring fluctuations were observed through the polished Lucite cylinder with a stroboscope and the motions that might cause breakage were photographed with a high-speed motion-picture camera. The camera was a continuous-film, rotating-prism type capable of taking pictures at the rate of 2500 frames per second. The light necessary for high-speed photography was supplied by an 8000-watt carbon arc light supplemented with flood lamps. Some of the high-speed pictures were taken with the cylinder and the exciter assembly mounted on a pivot, which rotated the assembly past the stationary camera to permit a 360° view of the ring.

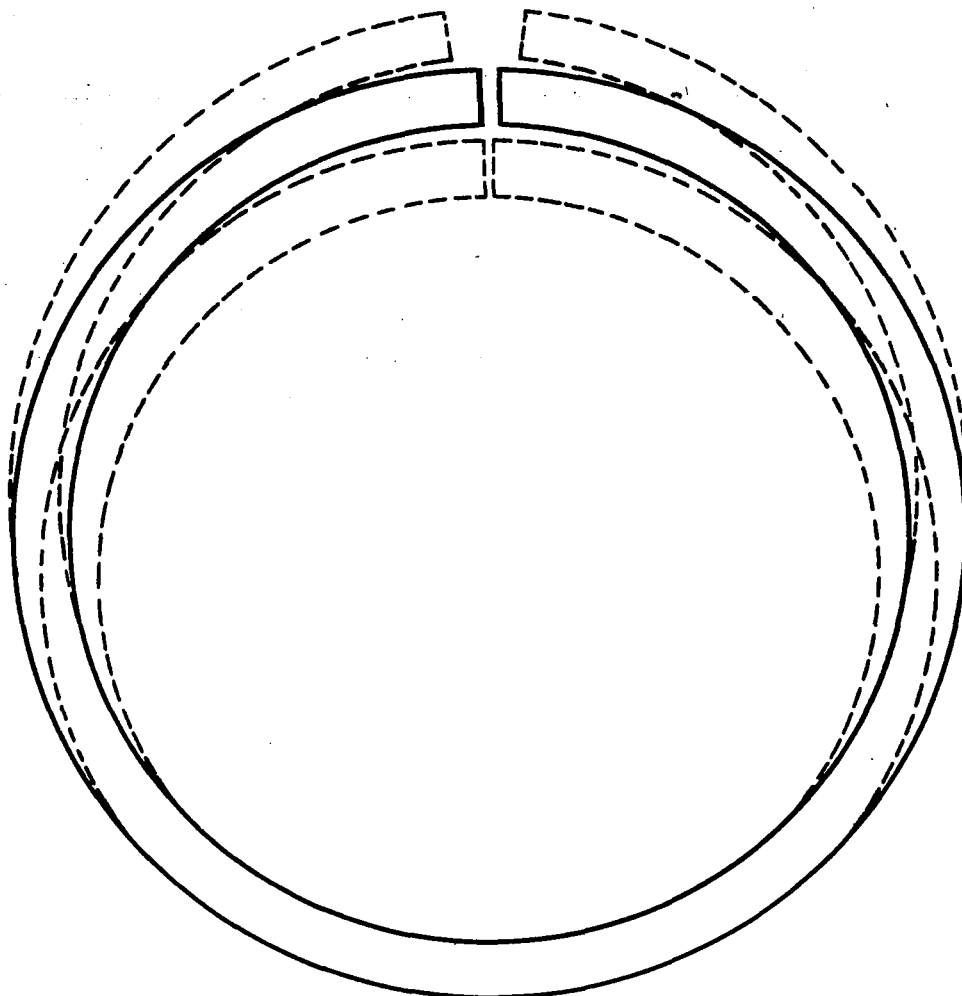
Radial or parallel vibration

Axial or transverse vibration

Figure 2. - Types of motion associated with vibration of piston rings.

Loading applied radially in the plane of the ring caused deflections like those resulting from what is known as radial or parallel-ring vibration. Loads acting on the ring perpendicular to its plane produced deflection curves similar to those formed by axial or transverse-ring vibrations (fig. 2). The fractures were compared with breaks that occurred in actual engine operation and it was found that all three fractures appeared to be the same. The moment required to break the ring in the axial direction averaged slightly less than 24 inch-pounds and in the radial-vibration manner it was approximately 48 inch-pounds. The breaking stress of the cast-iron ring material in bending was experimentally determined as 88,000 pounds per square inch. When the ring was so clamped as to form a 1-inch long cantilever, the axial deflection at the breaking point was about 0.025 inch, whereas the radial deflection was about 0.011 inch. It is feasible therefore to break rings by radial vibration because piston side clearance and ring back clearances would easily allow sufficient freedom.

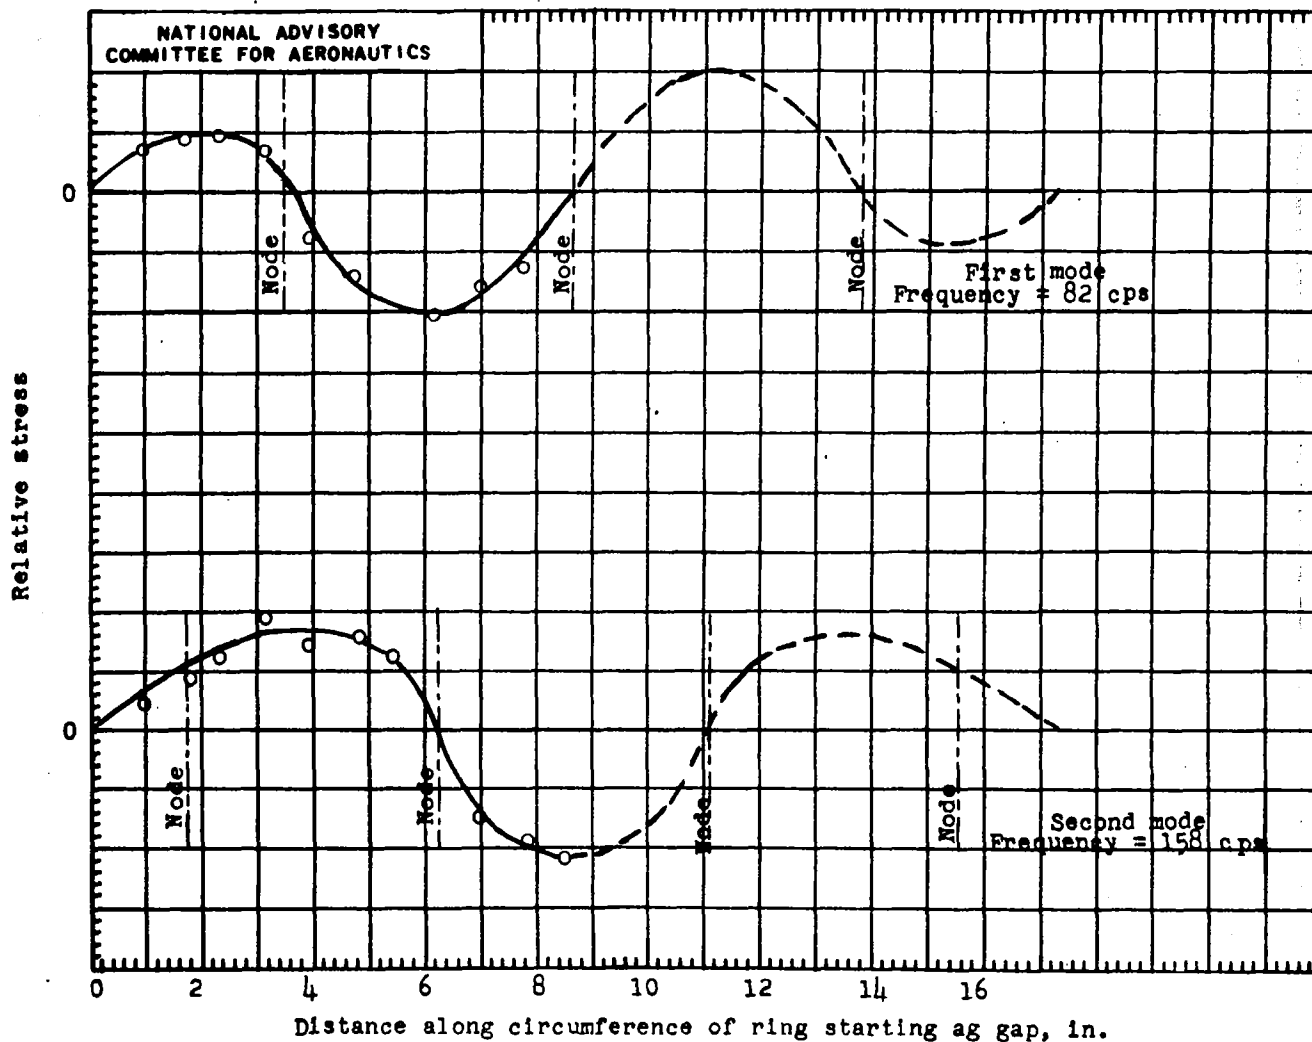
(a) First and second modes.

Figure 4. - Stress patterns of axial or transverse-ring vibration as shown by strain gages cemented on a compression piston ring of the keystone type. (Node points calculated from reference 4.)

An analysis of the strain-gage signals clearly indicated that the maximum stresses were located at the antinode points, or points of maximum displacement, with the exception of the antinode located at the extreme end of the ring. Figures 3 and 4 are plots of relative stresses along the length of the ring for radial-ring and axial-ring vibrations. All nodal points marked on these graphs were calculated from the tables in reference 4. The values in the tables were experimentally determined and were carried out only to the fifth and sixth modes for the axial and radial vibrations, respectively. For these highest modes, the closest antinode positions are still more than  $1\frac{7}{8}$  inches from the end. From figure 5, in which the antinode position closest to the end of the ring is plotted

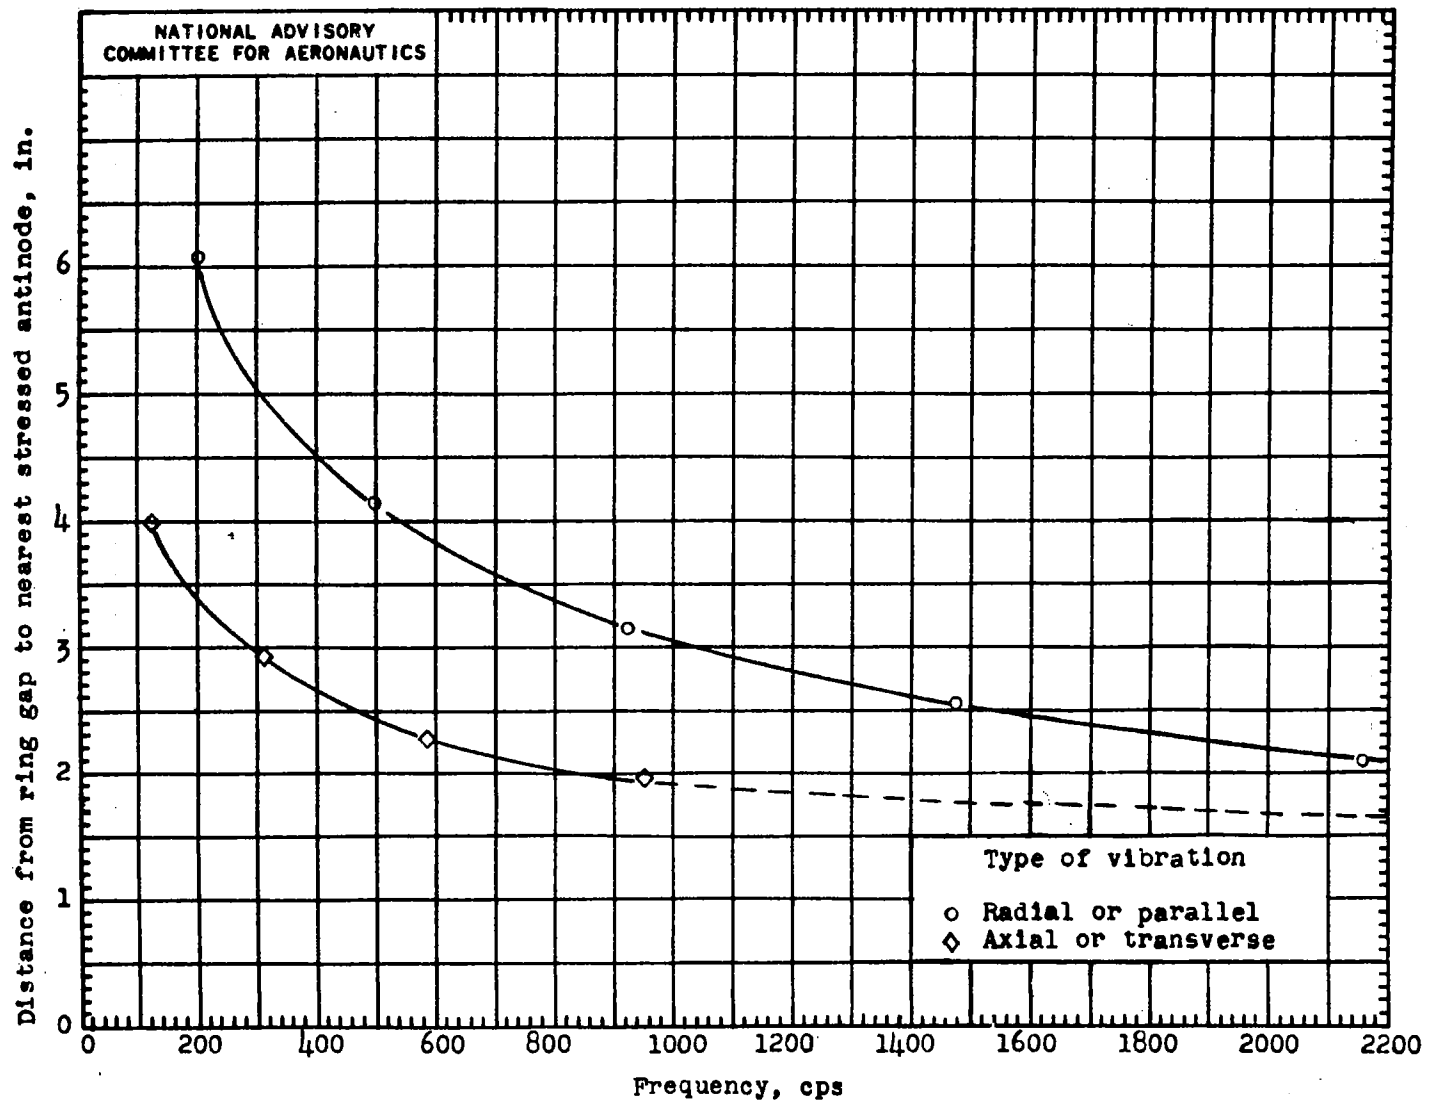
Figure 5. - A plot of natural frequency against the calculated distance from the gap of the ring to the nearest stressed antinode.

against frequency, it can be readily seen that breakage 1 inch or closer to the end by resonant vibration would require an extremely high frequency.

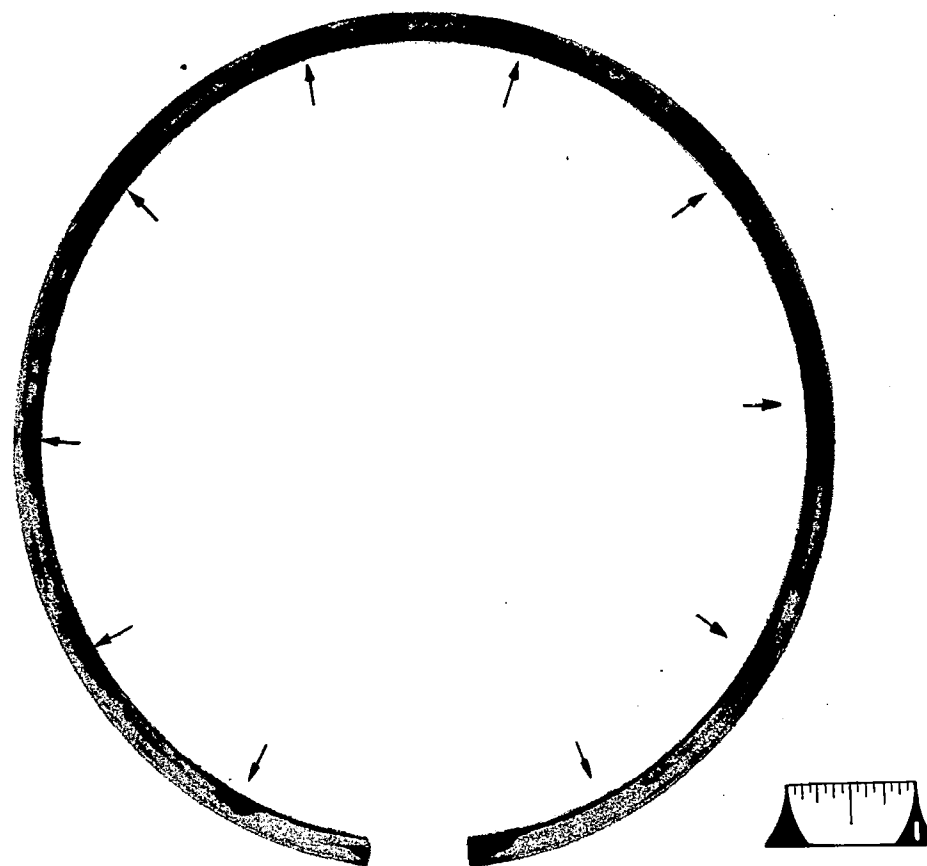
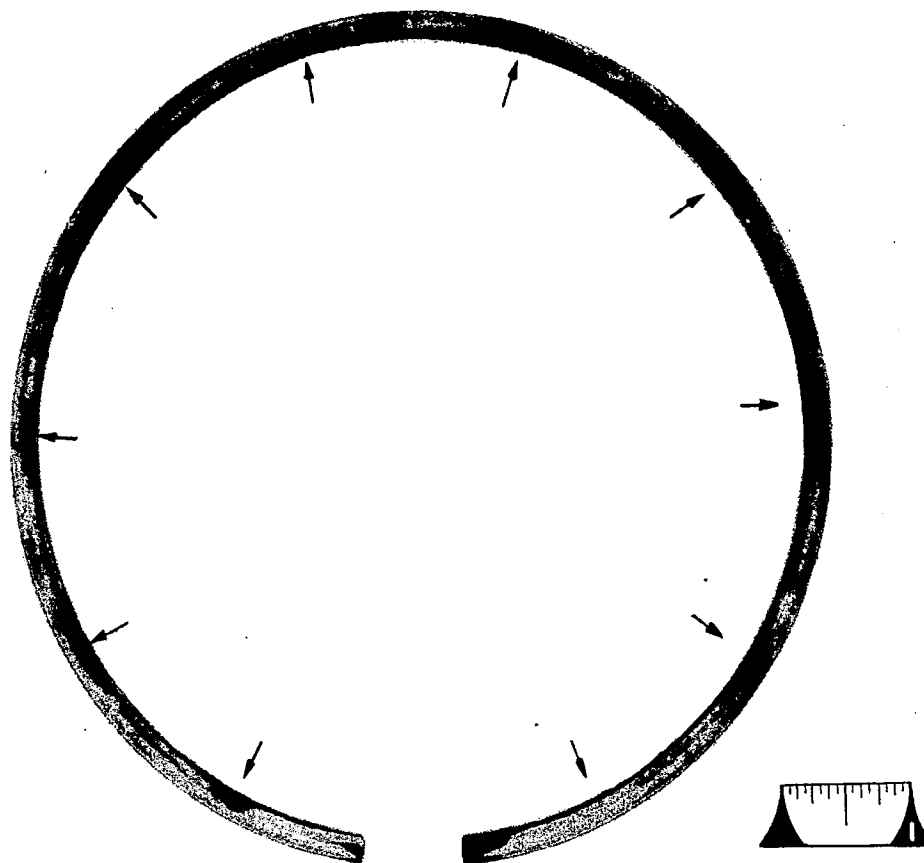
NACA  
C-6230  
8-2345

Figure 6. - Piston ring showing symmetric and even spacing of discoloration believed to be the result of eighth-mode axial vibration.

A ring vibrating in an eighth-mode axial manner would deflect in a wave form with 10 nodal points. (The frequency calculation is given in the appendix.) In this case, hot gases would flow by the ring, especially at the nodal points, because the deflection would prevent these points from properly seating against the piston land. The antinode points strike the lands very rapidly; consequently, the points are bright owing to wear and heat removal as well as to interruption of gas leakage at these points. This condition might satisfactorily explain the even spacing and the symmetrical location of the discoloration on the under side of the piston ring shown in figure 6, which indicates that vibration of the ring did exist. This piston ring was removed from a single-cylinder test engine after 50 hours' running time at constant speed and power. Such discoloration has been previously attributed to an uneven surface caused by grinding chatter during manufacture of the ring but such reasoning would not account for the perfect symmetry of the discoloration or the fact that rings operated at other powers seem to show a different number of discoloration points.

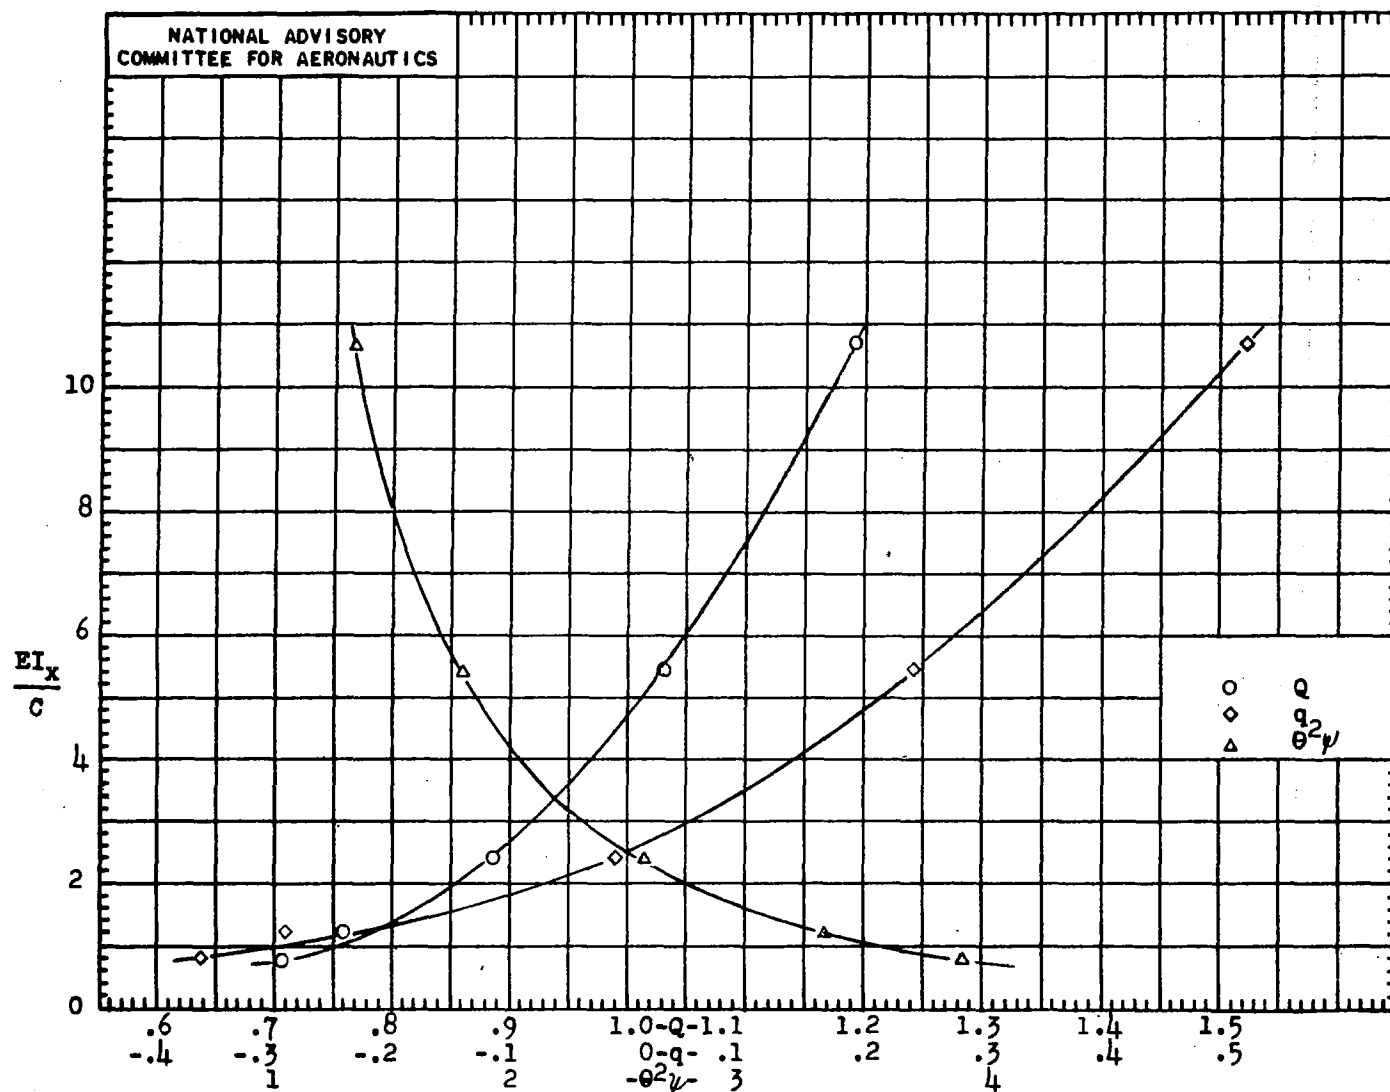
Figure 7. - Constants  $Q$ ,  $q$ , and  $\theta^2_p$ , which are used in the equation for the axial or transverse ring vibration frequency. (Values from reference 4.)

$Q, q, e^2 \psi$  constants dependent upon value of  $\frac{EI_x}{C}$  where  $C$  is torsional rigidity given by  $\beta bc^3 G$  (See fig. 7, which is a plot of values given in reference 4.)

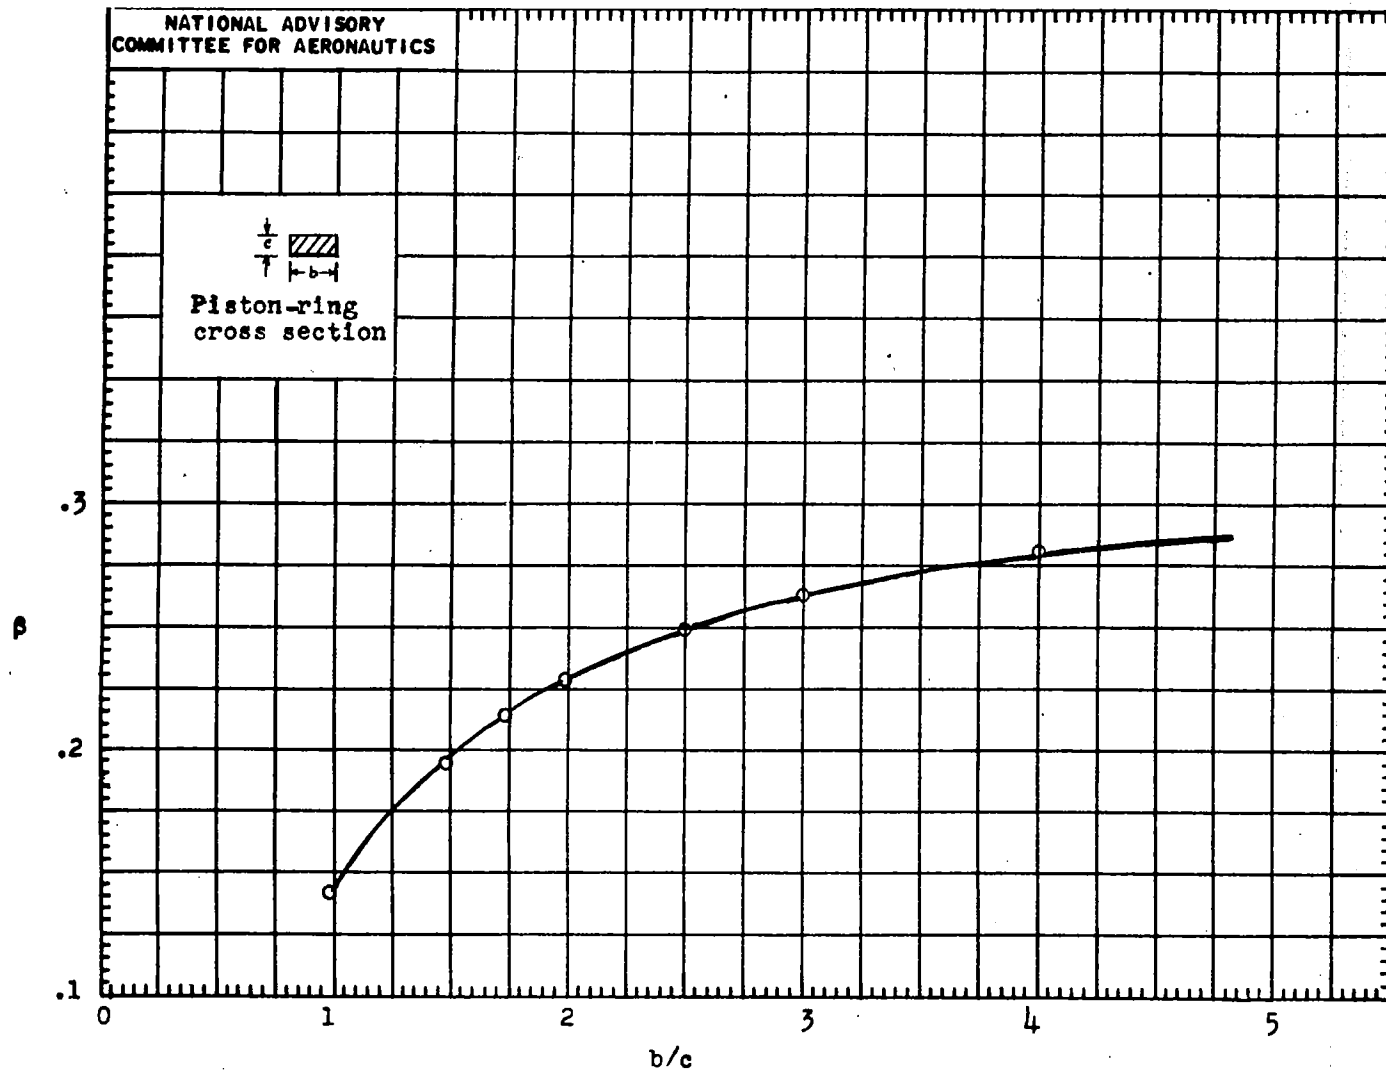
Figure 8. - Relation of the factor  $\beta$  to the length-width ratio  $b/c$  of piston-ring cross section. (Data from reference 7.)

$\beta$  constant dependent upon  $b/c$  (See fig. 8, which is a plot of values given in reference 7.)
